## IDAHO CAPITOL RESTORATION

Department of Administration  
Construction Update No. 52  
September 19, 2005

## Eagle Gilding Complete; Stone, Masonry Repair Continues; Workers Focus On Windows, Skylights

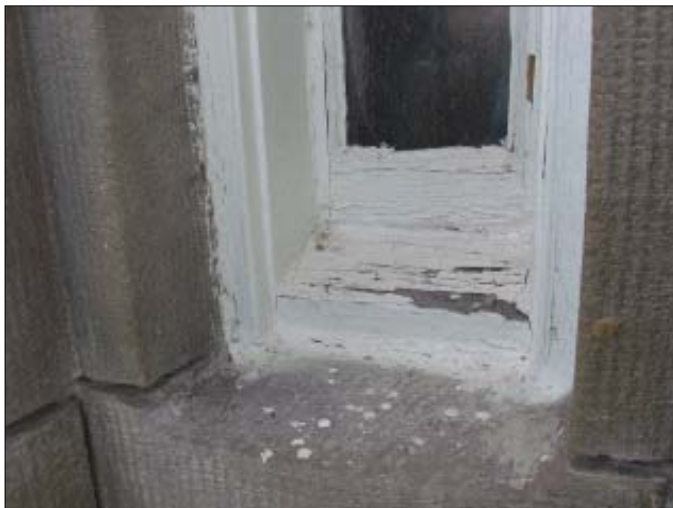
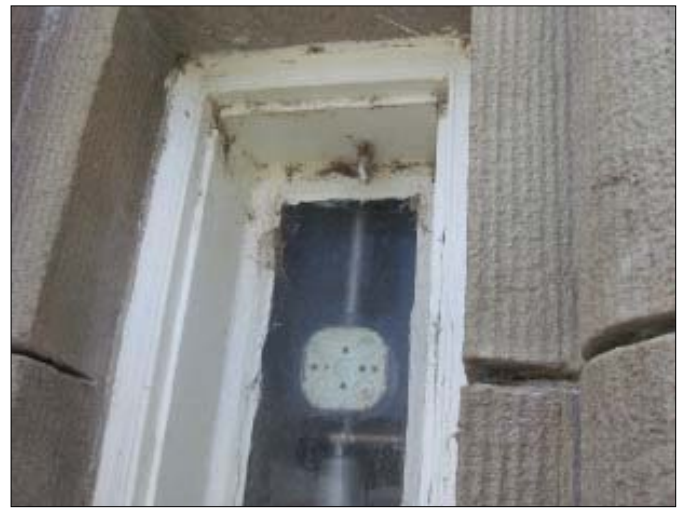
**At one time, lighting fixtures were attached to the urn edifices surrounding Dome at Urn Level.**

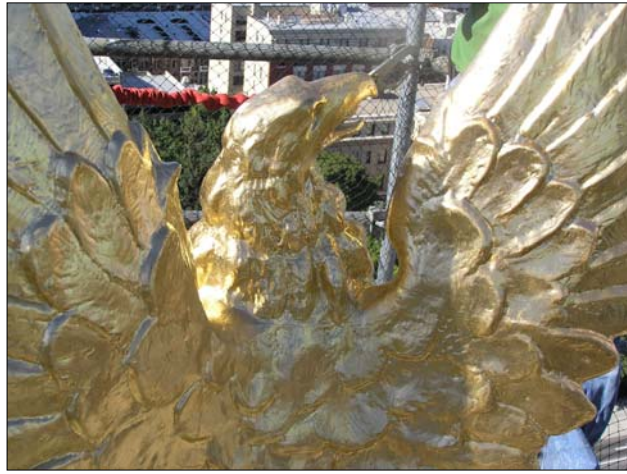
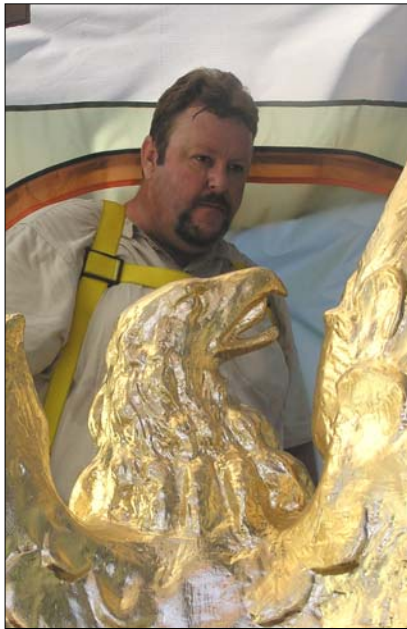
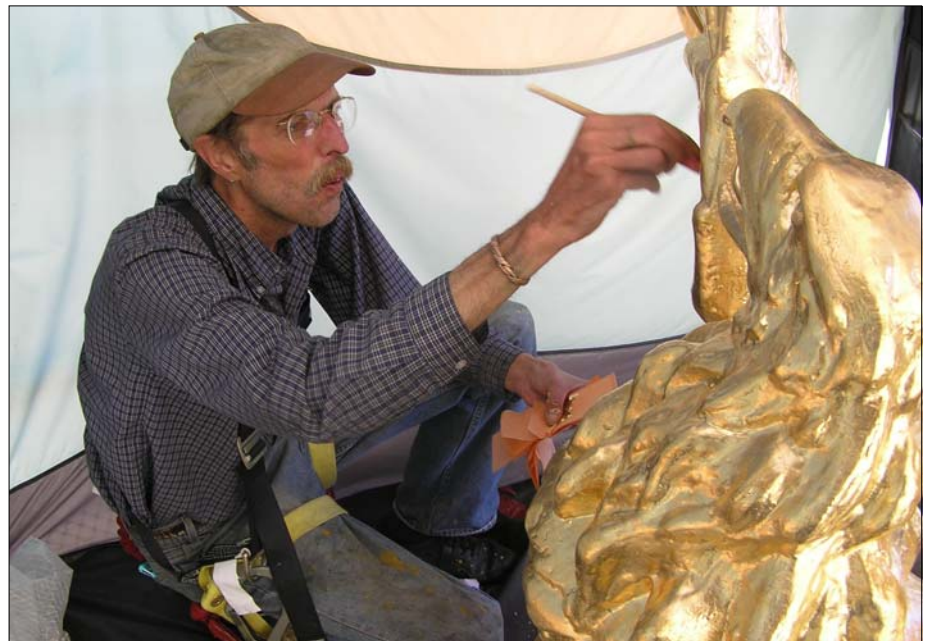
# Statehouse Eagle Glitters in Gold Over Idaho's Capitol City

**Joe Rutledge**, Division of Public Works, has watched the intricate gilding process of Idaho's Statehouse Eagle unfold over the past couple of months. Now completed, Joe says witnessing the eagle's restoration has been both a privilege and a very memorable experience.

**Boise Artist Michael Kobold** of Raggle Day Studios applies the thin layers of gold leaf, using a brush and static electricity to create a magnetic-like surface on the eagle's exterior to capture the very fine layer of gold (**photos below**). A tent provided both the artist and the statue protection from the wind and elements during the process.
